## Overview of Ongoing Remedial Investigations Kerr-McGee Chemical Corporation Superfund Site, Navassa, North Carolina December 7, 2016

## Use of Innovative Technology for Remedial Investigations at Navassa Superfund Site

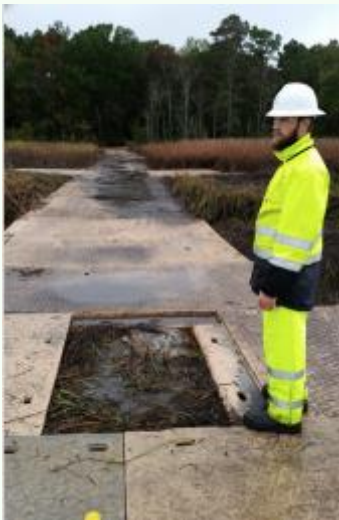
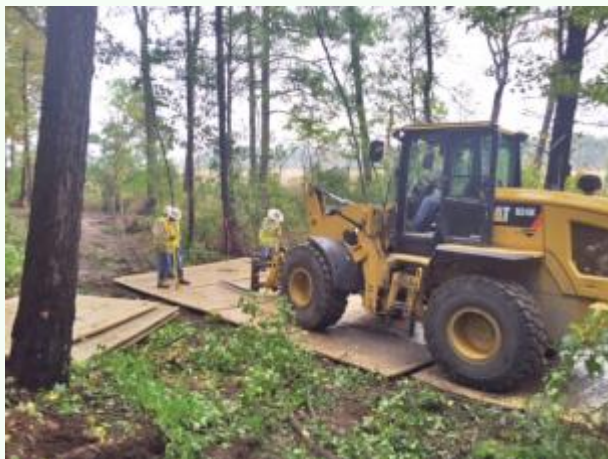
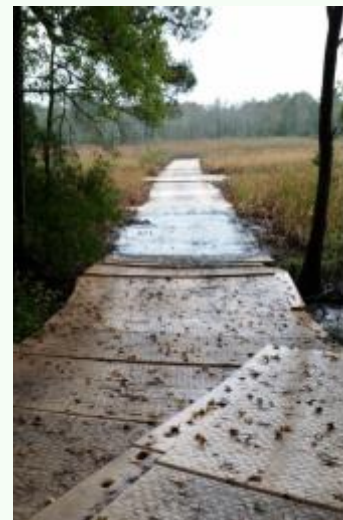
A temporary concourse of more than 300 high-density polyethylene mats was installed to protect the marsh environment while creating a stable surface for drill rigs and other heavy equipment to collect samples in the marsh. A sampling window (below left) is open in the mats to allow access to soils and sediments.

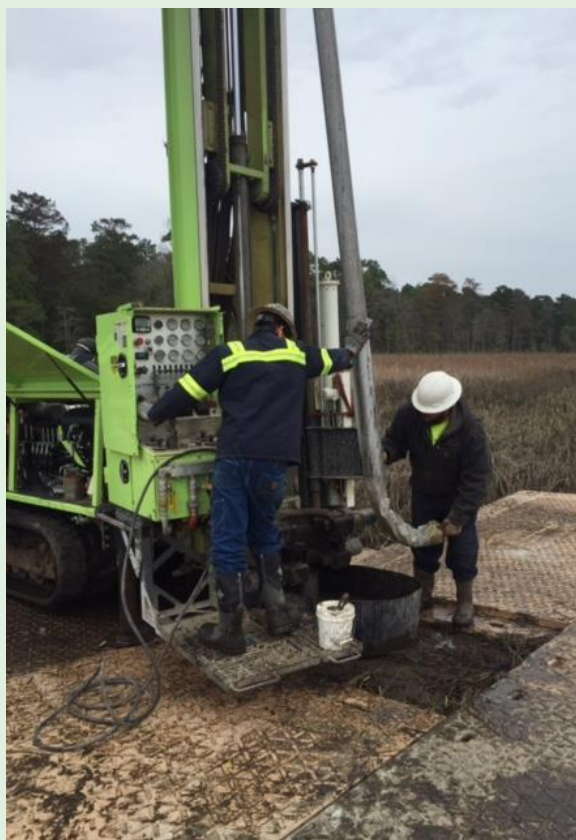
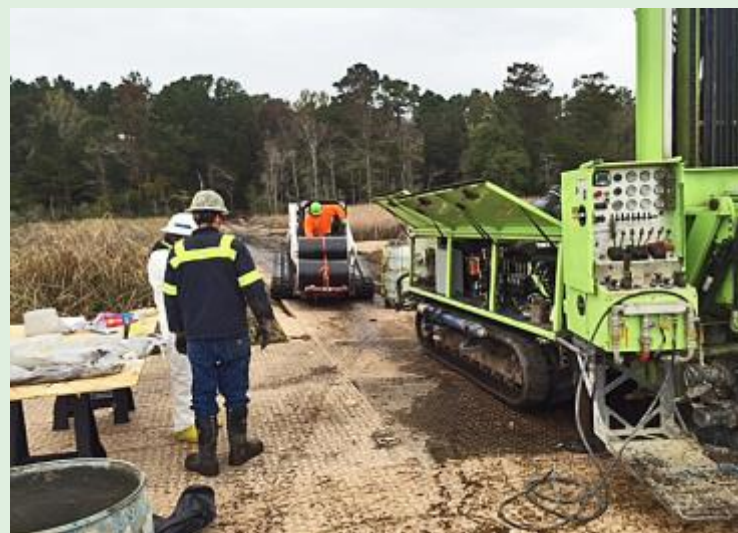
A track-mounted rotosonic drill rig (above and left) was used to rapidly penetrate coastal lithologies and minimize waste generation. The drill rig recovered continuous soil cores as deep as 100 feet below ground surface (bgs). Geologists inspected and screened the cores to characterize site geology and evaluate contaminant distribution.

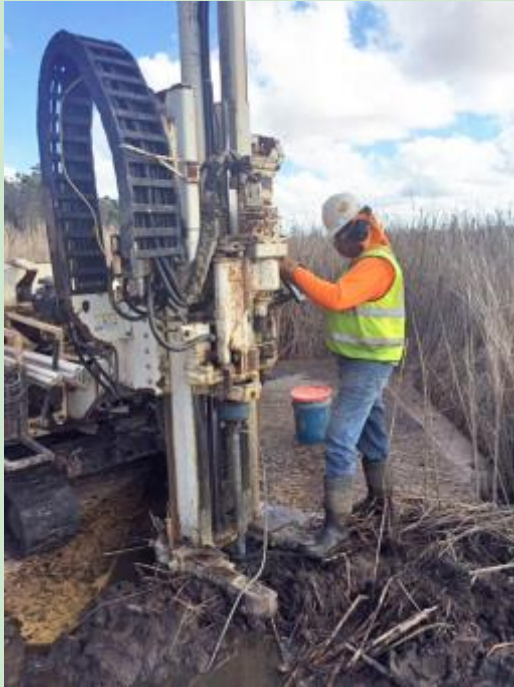
The laser-based Tar-specific Green Optical Screening Tool (TarGOST) system (below left) was deployed to quickly and cost-effectively characterize the vertical profile of non-aqueous phase liquid (NAPL) using the TarGOST high-resolution technology. The TarGOST system was deployed with direct push technology (DPT) equipment (below right), although thin layers of dense limestone limited DPT penetration to 40 to 70 feet bgs. TarGOST responses indicated potential NAPL in the marsh sediments, but not in the underlying sandy soils. Based on borings completed near the waste water ponds, TarGOST results also suggested weathering of NAPL near that area based on the difference in instrument signature results.

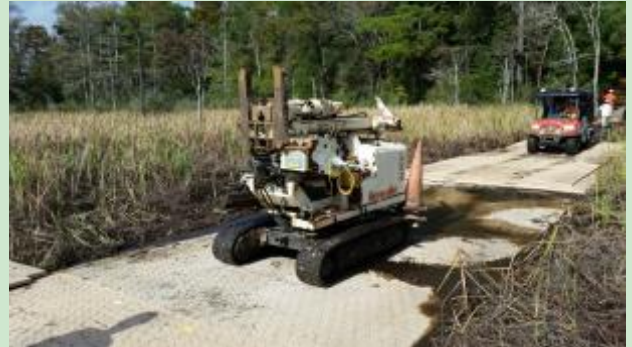
A Vibracore sampling system was used to collect continuous cores of soft, loose marsh sediment that cannot be recovered with rotosonic drill equipment. Cores were inspected and screened, and samples were collected for analysis and comparison with TarGOST profiles to clarify the differences in TarGOST responses between the borings in the marsh and those near the waste water ponds.

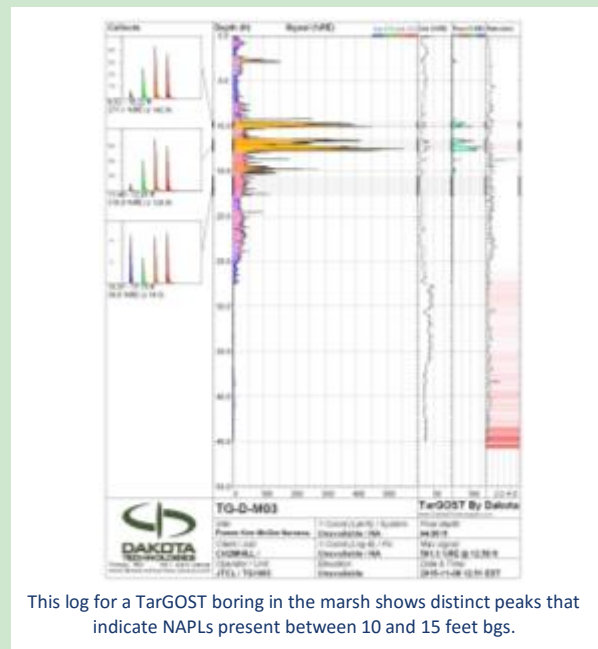
This log for a TarGOST boring in the marsh shows distinct peaks that indicate NAPLs present between 10 and 15 feet bgs.
