Overview of Remediation Progress and Plans

Kerr-McGee Chemical Corp – Navassa Superfund Site, Navassa, North Carolina

June 2019

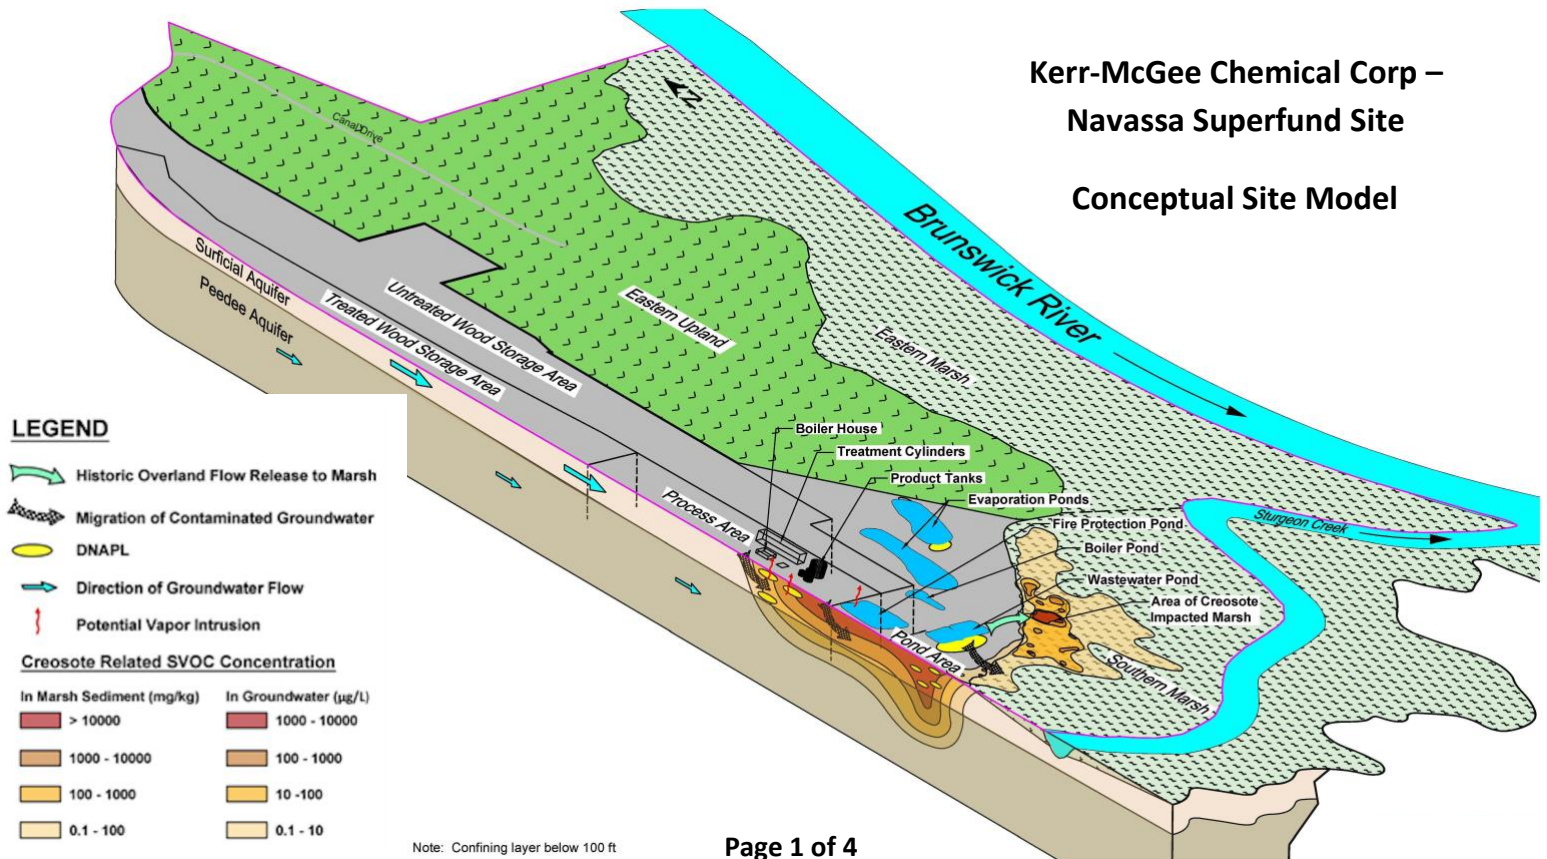
**Kerr-McGee Chemical Corp –
Navassa Superfund Site
Conceptual Site Model**

From 1936 to 1974, the 246-acre Site was used for treating wood. Dried lumber for railroad ties, utility poles and pilings was pressure-treated with creosote in Treatment Vessels. Treated lumber was then allowed to dry outside. Treated and untreated lumber was stockpiled and stored in the Treated and Untreated Wood Storage Areas. Creosote was stored in aboveground Product Tanks.

Process water was discharged into two unlined Wastewater Ponds, where creosote was separated from water for reuse in the treatment process. Water from the Wastewater Ponds was either reused as cooling water or discharged into an Evaporation Pond. A Fire Protection Pond was used to store water for fighting facility fires, and two Boiler Ponds received water from boiler operations used in the treating process.

By 1980, the wood-treatment operation was dismantled, its buildings and facilities demolished. At that time, creosote sludge from the Wastewater Ponds and Product Tanks reportedly was mixed with clean fill, and then disposed in the Wastewater Pond basins, which were backfilled and vegetated. The Boiler Ponds were drained of water, and the Boiler Pond basins were backfilled and vegetated. The Fire Protection Pond dike was breached, and the pond drained.

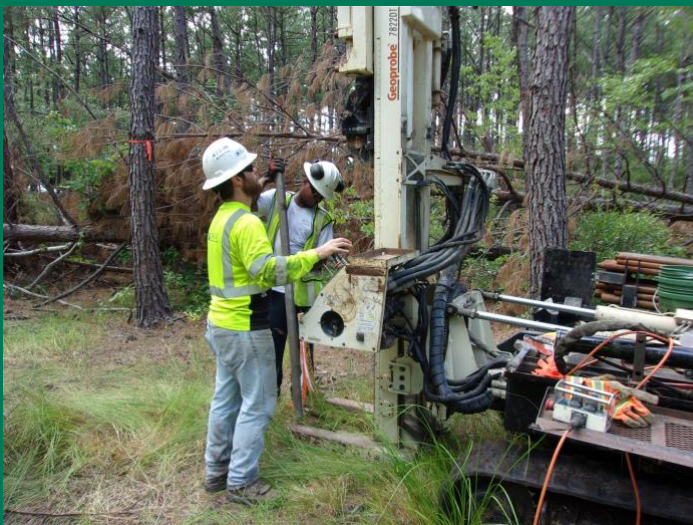
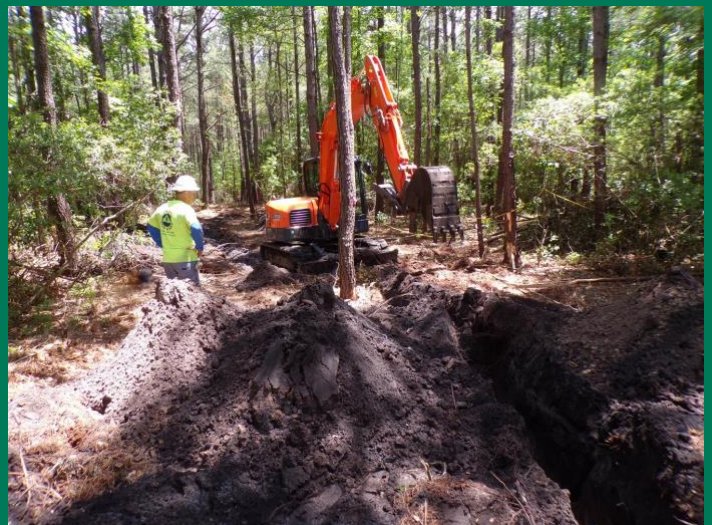
Photos of Our Soil Sampling Activities, 2018–2019

In June 2019, during soil sampling in the northern area of the Site, a Multistate Trust contractor's team (left) collects soil samples using a Geoprobe drilling rig. In May 2018, a Multistate Trust contractor's team (right) installs trenches to collect soil samples needed to evaluate subsurface conditions.
